SIO Shipyard Representative Bi-Weekly Progress Report		
Project: AGOR 28	Contract No.: N00014-12-C-0305	Shipyard: Dakota Creek Industries
Prepared by: Paul D. Bueren Scripps Institution of Oceanography (SIO) 297 Rosecrans St. San Diego, CA 98106	Date: 22 April 2016	Program Officer: Robert (Tim) Schnoor Office of Naval Research 875 Randolph St ONR 321 Arlington, VA 22203-1995
Distribution Statement A: Approved for public release; distribution unlimited.		Report No. A002.098

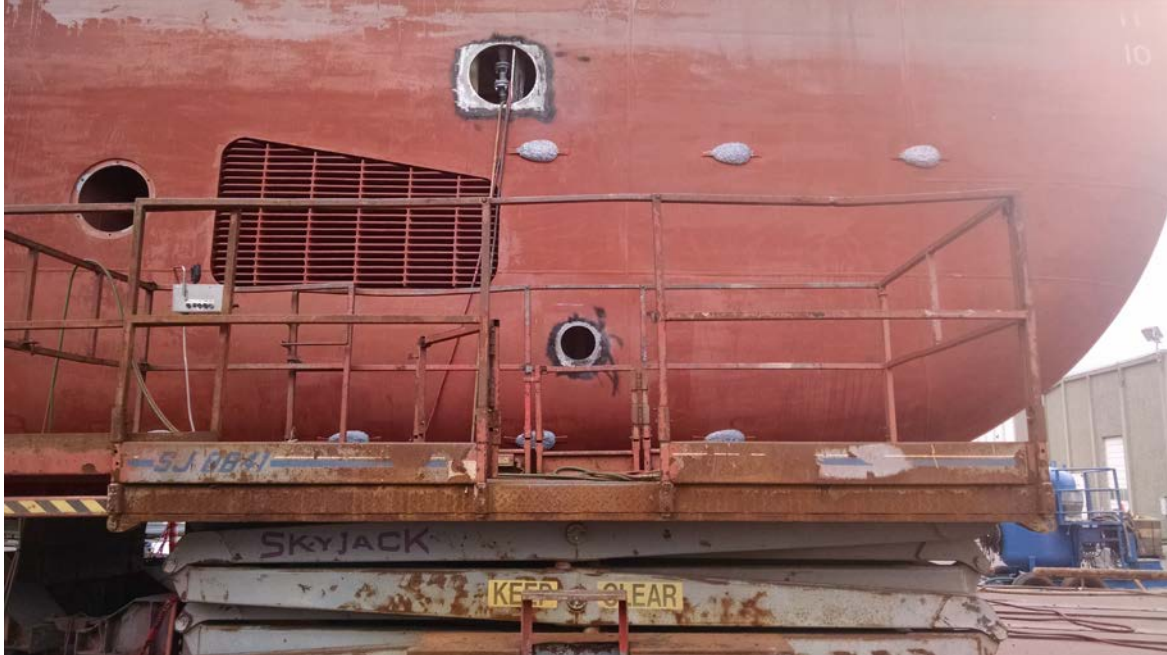
- Uncontaminated Sea Chest – Original sea chest removed and penetration made at new location

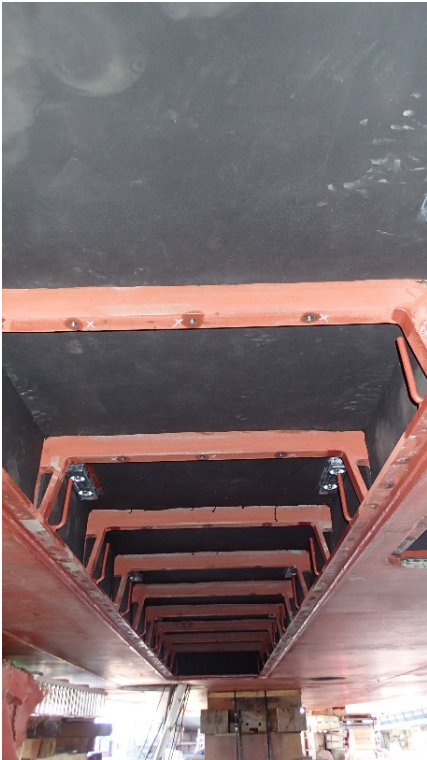
- Anchor Pocket Shims – Shims are being fabricated with installation to begin next week
- EM122 – The frames for the transmit and receive arrays are fully installed and surveyed in. Minimal shimming required. Zincs and sound dampening material were installed prior to mounting the frames. The transducer modules are lined up and ready for installation.

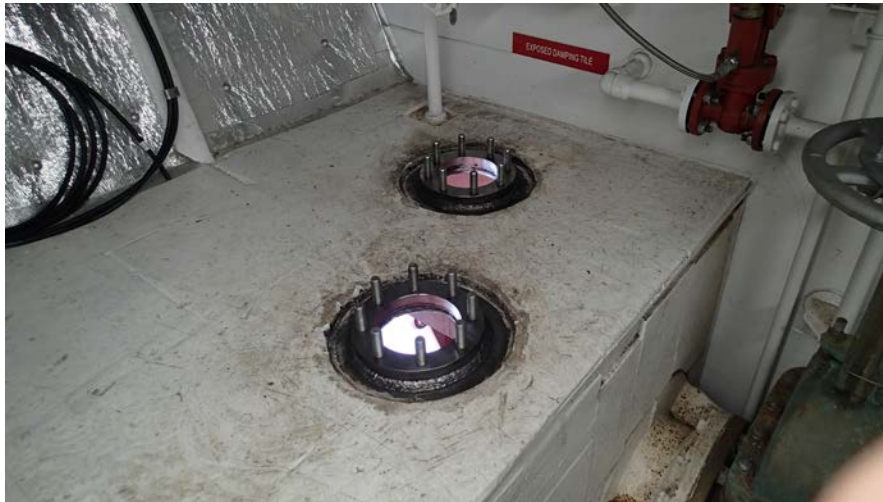
- Sea Chest Anti-Bio Fouling System WP10 – The anode flanges have been fitted and welded to the three sea chests. ABS on site to inspect welds. Cable runs are complete.

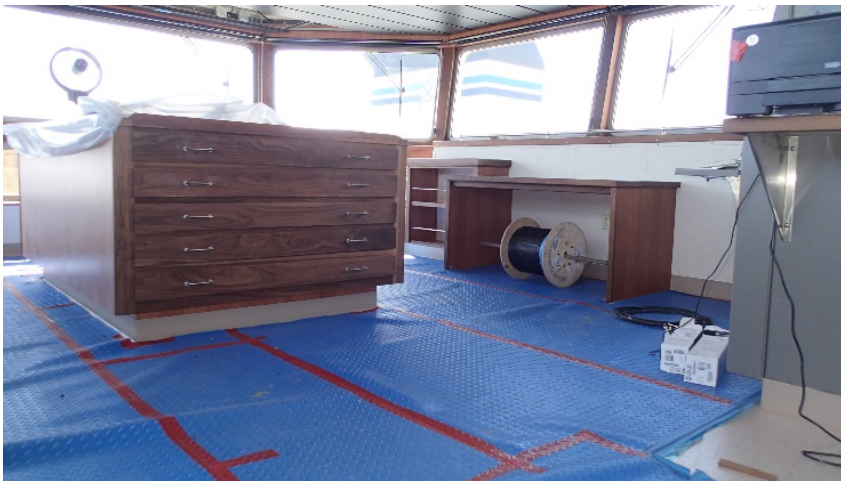
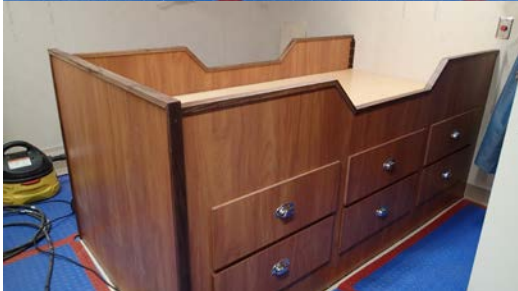
- Fire Pump Sea Chest De-icing Line – Piping run is complete and ABS witnessed pressure test of the sea valve. Yard to pressure test entire run next week.
- Transducer Mods – Work continues apace on the additional transducer foundations and the modifications to the existing foundations. ABS inspected welds and witnessed leak test.
- Furniture Configuration Change – Work completed in the pilothouse and hospital.

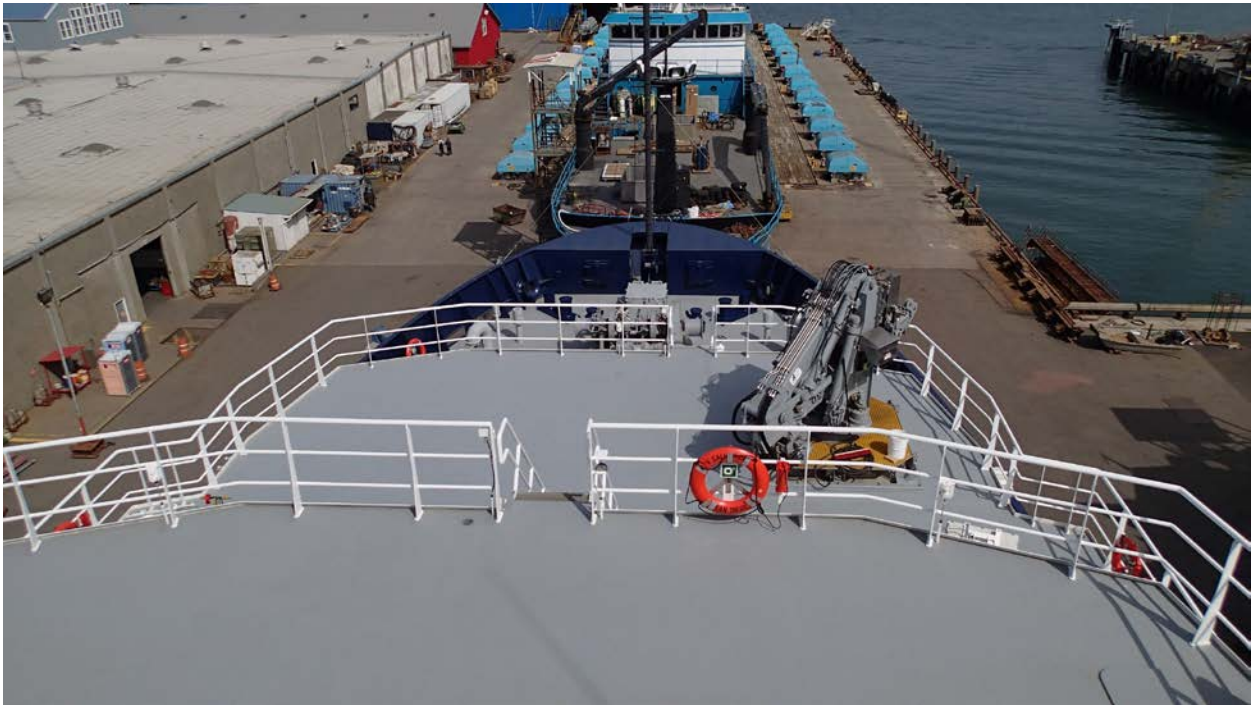
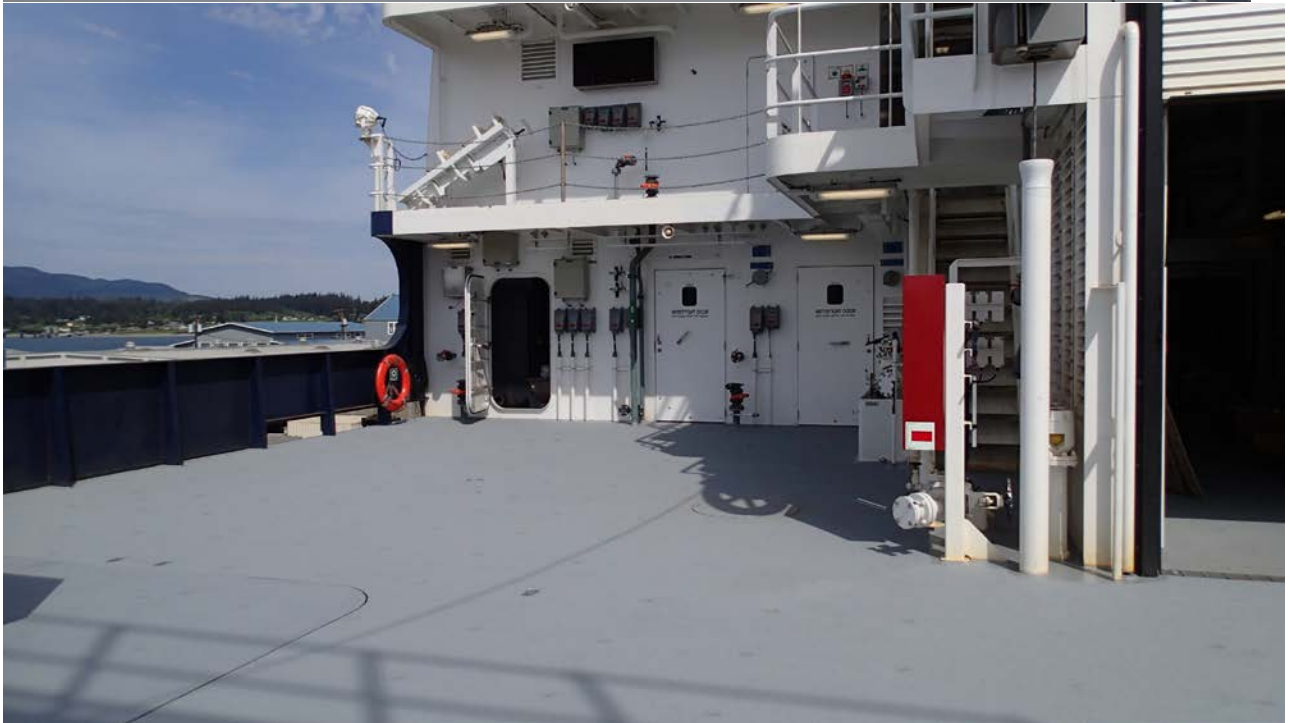
- Topside Paint – Looking good
